# Successful pericardial repair and coverage for late pacemaker lead-related atrial perforation and pneumothorax: a case report

**Case presentation** A woman in her 80s who had undergone permanent pacemaker implantation 2 years previously visited our hospital because of dyspnea. She had also been treated for right pneumothorax 1 year previously. A chest radiograph and computed tomography scan showed right pneumothorax and pericardial emphysema with no effusion. Because similar findings had been obtained at the previous onset of pneumothorax, we suspected delayed myocardial perforation and lung injury due to the screw-in lead in the right atrium. No myocardial bleed-ing, cardiac tamponade, or pacing failure was present. The cardiovascular surgeon judged that open-heart lead extraction would be difficult because of the patient's poor performance status; therefore, thoracoscopic pericardial repair with an expanded polytetrafluoroethylene sheet and coverage with anterior mediastinal adipose tissue was attempted to prevent recurrent pneumothorax. The patient was successfully treated without lead extraction or open heart surgery. At 1.5 years postoperatively, she had developed no recurr

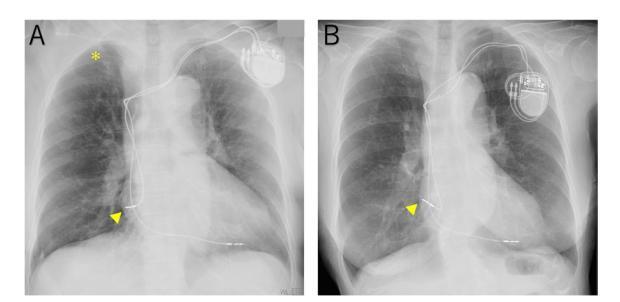
**Fig. 1** Chest X-ray images. A X-ray images taken in the sitting position on admission. The asterisk (\*) indicates the area of the collapsed lungs. The yellow arrowhead indicates the tip of the lead. **B** X-ray images were taken immediately after pacemaker implantation. The yellow arrowhead indicates the tip of the lead. The position of the tip has migrated

A woman in her early 80s presented with a 10-day history of dyspnea and chest discomfort. She had undergone PMI (dual chamber pacemaker-defibrillator with screwin lead) for complete atrioventricular block 2 years previously, and she had developed right pneumothorax that was treated by chest drainage 1 year previously. She was an ex-smoker (61 pack-years), 142.0 cm tall, and 50.2 kg in weight, and her performance status is 1. A chest X-ray showed collapse of the right lung (Fig. 1A). Compared with the image obtained immediately after PMI (Fig. 1B),

the right atrial lead tip was misaligned. An electrocardiogram showed a heart rate of 81 beats per minute and sinus rhythm with self-pulsation (Fig. 2A), whereas the electrocardiogram obtained immediately after PMI showed a pacing waveform (Fig. 2B). The pacemaker worked normally with no pacing failure. Chest computed tomography (CT) showed right pneumothorax and pericardial emphysema (Fig. 3A). No pleural or pericardial effusion was present. However, the tip of the right atrial lead appeared to be located outside the right atrial wall. Delayed myocardial perforation and repeated pneumothorax due to the right atrial lead were suspected. A treatment plan was discussed among respiratory surgeons, cardiologists, and cardiovascular surgeons, who considered that open chest surgery to remove the lead would be difficult because of the patient's poor performance status. Fortunately, no cardiac bleeding, tamponade, or pacing failure had occurred. Therefore, a thoracoscopic covering of the lead tip was attempted.

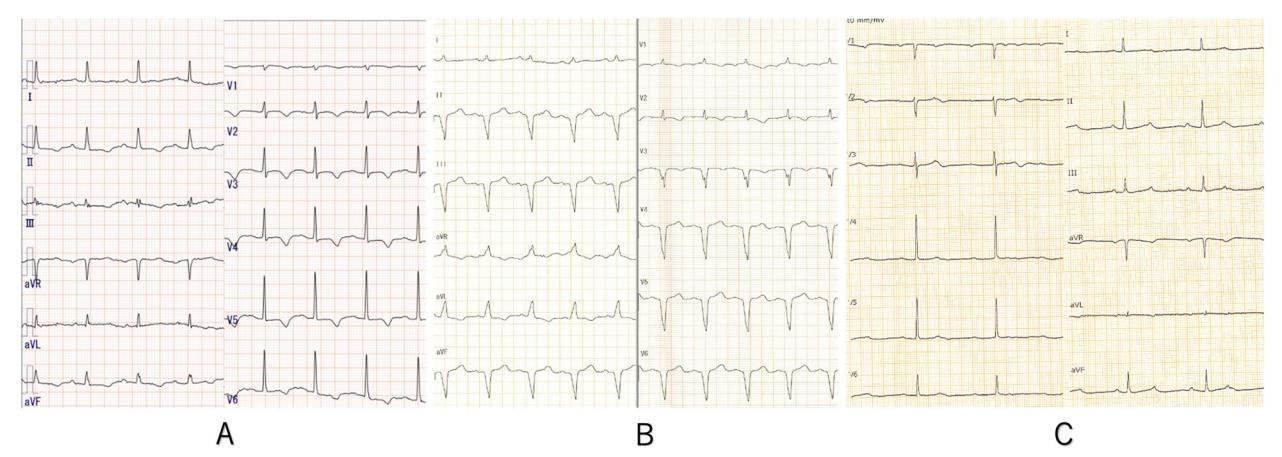
Fig. 2 Electrocardiogram. A Electrocardiogram on admission shows a self-pulse. B Electrocardiogram after pacemaker implantation shows pacing waveforms. C Electrocardiogram on complete atrioventricular block

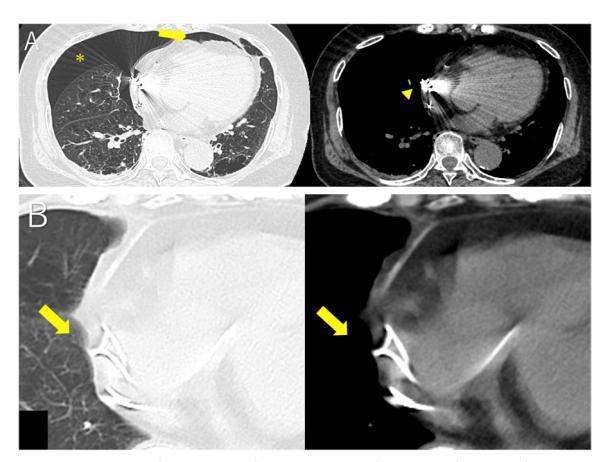
Fig. 3 Computed tomography images. A The asterisk (\*) indicates the area of the collapsed lungs. The yellow arrow indicates pericardial emphysema. The yellow arrowhead indicates the tip of the lead. The tip appears to be outside the myocardial wall. **B** Postoperative computed tomography image. Pneumothorax has not recurred. The yellow arrows indicate residual adipose tissue at the tip of the right atrial lead

discharged within a few days. At 1.5 years after surgery, the pneumothorax had not recurred and the pacemaker had not failed. Postoperative CT images indicated residual adipose tissue at the lead tip (Fig. 3B).

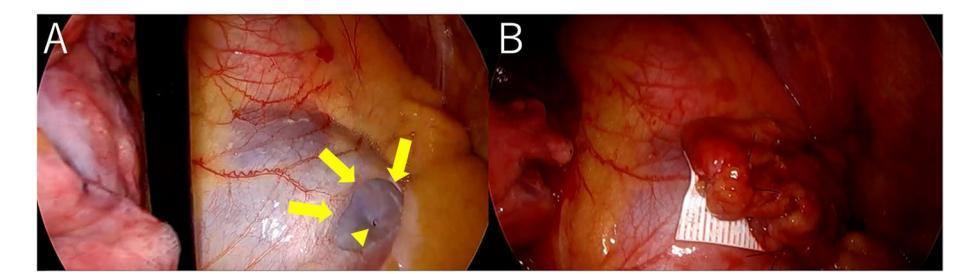
Fig. 4 Surgical findings. A The yellow arrowhead indicates lead tip protrusion from the right atrial wall. The yellow arrows indicate pericardial defects. B An expanded polytetrafluoroethylene sheet and anterior mediastinal adipose tissue were sutured to the pericardial defect

The surgical findings are shown in Fig. 4. The pacemaker lead had perforated the right atrial wall. The pericardium at the same site was ruptured, and the defect was almost  $1 \times 2$  cm in size. The scratched pleura of the lung that was in contact with the lead had turned white and become thickened with inflammation. The pericardial defect was repaired with an ePTFE sheet. We used the ePTFE sheet that was  $2 \times 3$  cm in size and sutured the ePTFE sheet to the pericardium at four locations using 4-0 prolene <sup>®</sup>(polypropylene). In addition, anterior mediastinal fat tissue made use of a pedicled fat flap and sutured over the ePTFE sheet at two locations using 4-0 prolene <sup>®</sup>. The double-layer reinforcement was used as a pericardial replacement. The scratched lung site was reinforced using fibrin glue and polyglycolic acid felt. The patient had a good post-operative course and was
